LATERAL SOUND FLANKING TRANSMISSION AT CURTAIN WALL MULLIONS:
AN EMPIRICAL INVESTIGATION TO IDENTIFY CONTROLLING MECHANISMS

A Dissertation Proposal Presented to the

In Partial Fulfillment of the Requirements for the Degree
DOCTOR OF PHILOSOPHY IN ARCHITECTURE

August 2015

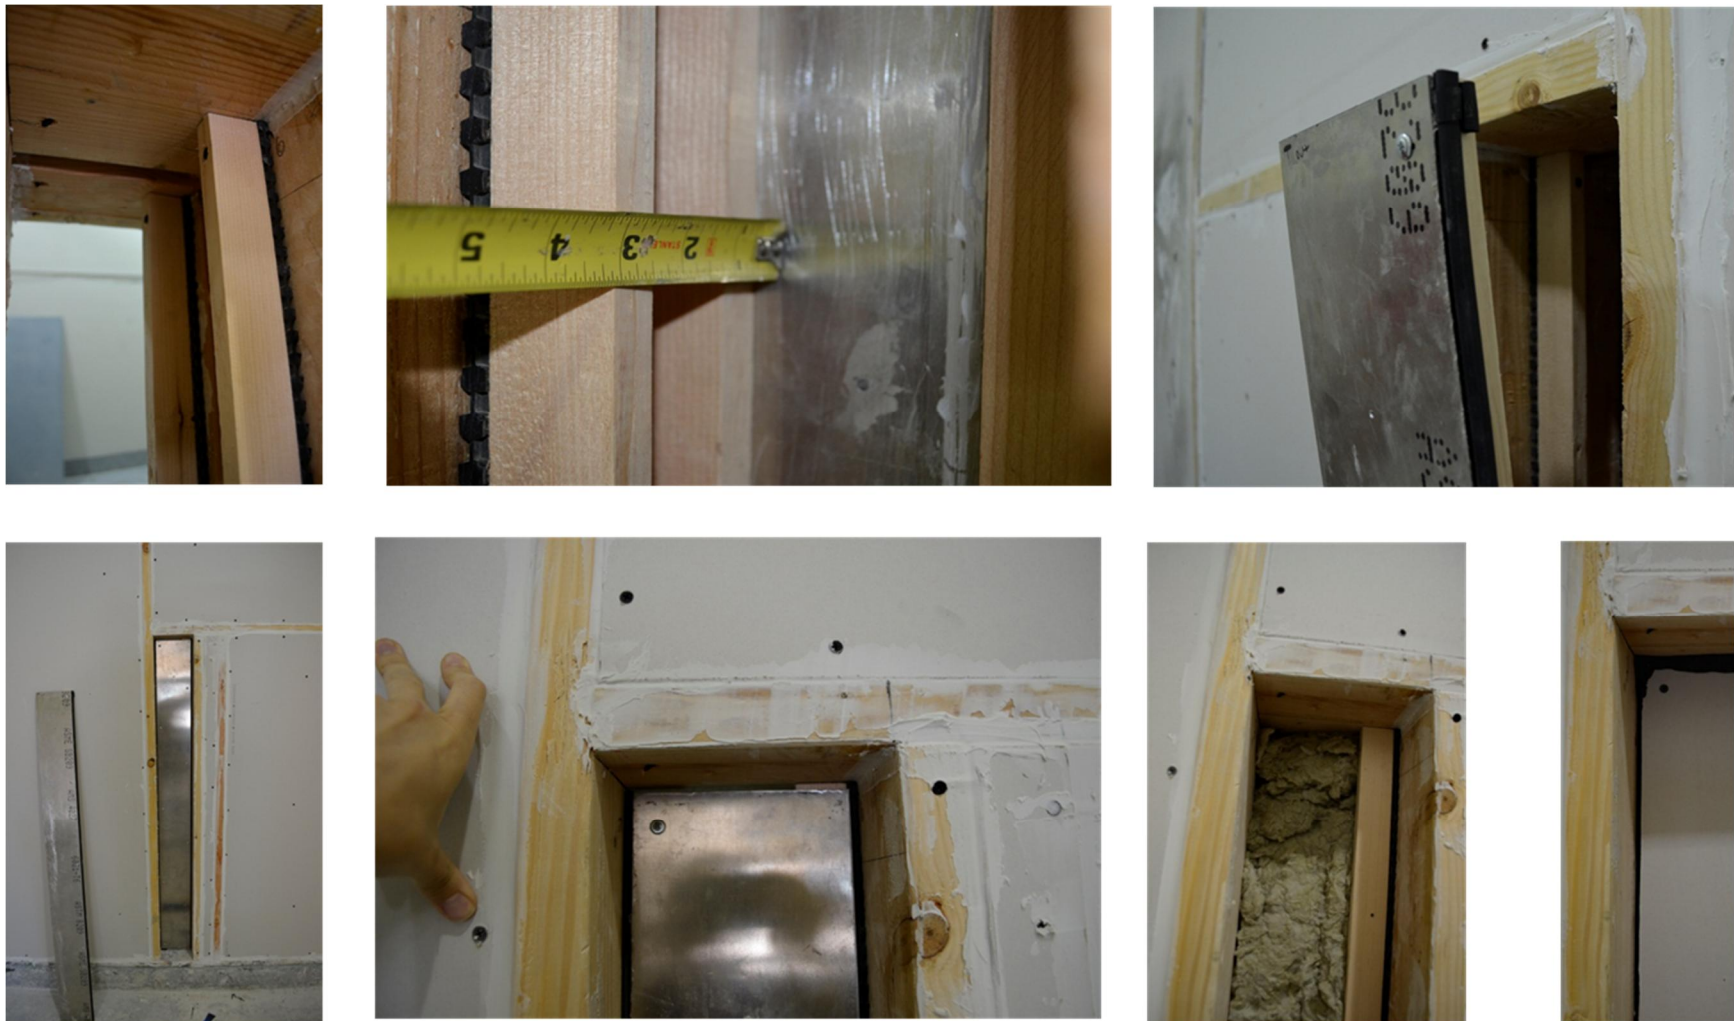
“Solid Plate” specimen construction

FIGURE 4-48: PHASE 2B CLASS A SPECIMEN CONSTRUCTION OF SOLID PLATE TESTS

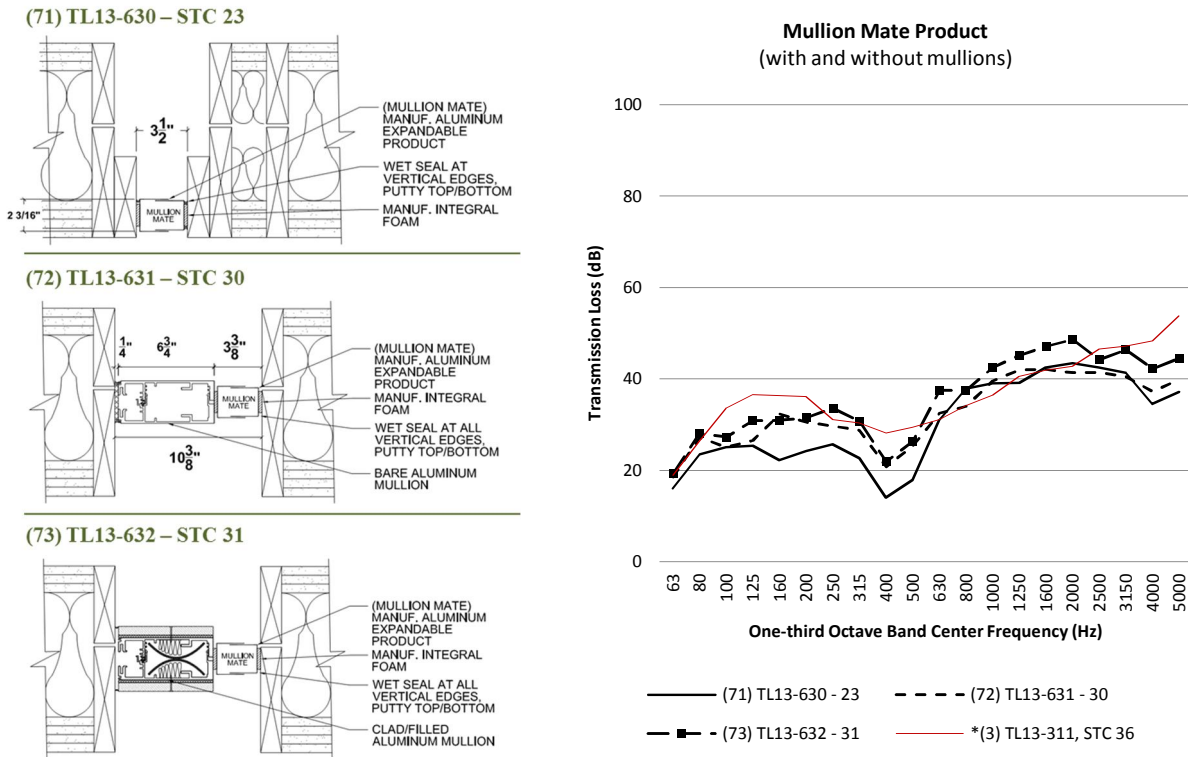
FIGURE 4-58: MULLION MATE (LEFT) AND MULL IT OVER (RIGHT)
