Vibration Isolation of a Medical Facility

An MRI (magnetic resonance imaging) facility was constructed only 50 ft from a busy railroad line. This case history shows how careful design, analysis, testing and construction can provide a completely successful solution to a very severe problem.

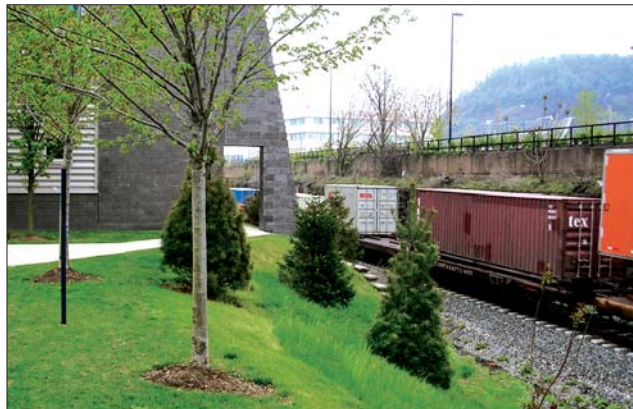
Figure 1. USX rail line adjacent to UPMC Sports Medicine Center building.

The UPMC Sports Performance Center is a part of an urban revitalization project located on land that until the 1980s housed a Jones & Laughlin Corporation (later LTV) steel plant. The narrow half-mile strip of land is bordered on one side by the Monongahela River and on the other side by a CSX rail line. The rail line is one of the busiest in the Eastern United States. More than 60 trains per day pass on an unpredictable schedule.² The center's close proximity to the CSX rail line can be seen in Figure 1.

The UPMC's original 0.7T MRI was located approximately 50 ft from the rail line in the corner of the building (Figure 1). This MRI was installed on a concrete slab at grade. In the absence of train traffic, ambient environmental vibrations of normal activities in and around the center satisfied the MRI manufacturer's vibration specifications. However, when a train passed scanning had to be terminated due to excessive vibrations. The unpredictable train traffic caused delays and scans to be repeated.

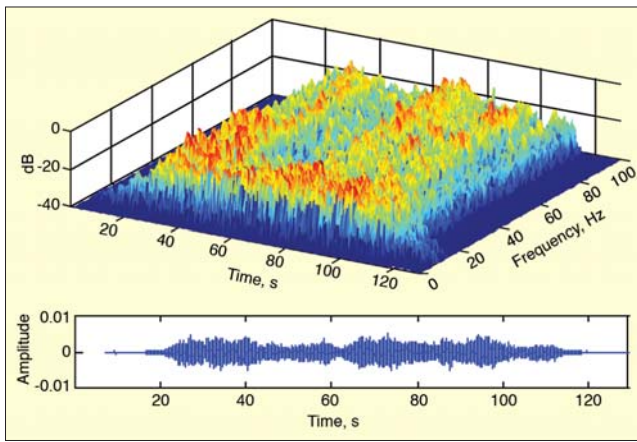
Figure 3. Short-time Fourier transform of ground vibration for train pass-by in Figure 2A1.

The STFT analysis in Figure 3 clearly shows the high spectral amplitudes produced by the transient events. The maximum spectral line qualification criterion is very sensitive to these high-amplitude, short-duration events; therefore, their inclusion in the processed data is crucial. To ensure accurate qualification assessment, the train pass-by vibration was captured in its entirety and analyzed using an approach that processed all events. The analysis method used the maximum spectral amplitude criterion, and the strategy employed in the STFT processing is described below.

value. This "sliding window" process is the basis of the STFT used to create the analyses in Figure 3. For vibration compliance evaluation, Equation 4 is used to create the spectrum in terms of g_{rms} for each incremental value of the shift variable τ . The shift increment is selected so that an overlap of 90% of the preceding sample is obtained. The maximum value observed in each spectral bin from all the samples is then retained as the window slides through the entire vibration time history. This analysis process ensures that the effects of all discrete transients are captured and used in the assessment criteria. A typical maximum spectral response computed by this method for the train ground vibration in Figure 2A1 is shown in Figure 4. This analysis will be used for compliance evaluations in all subsequent isolation system development steps.

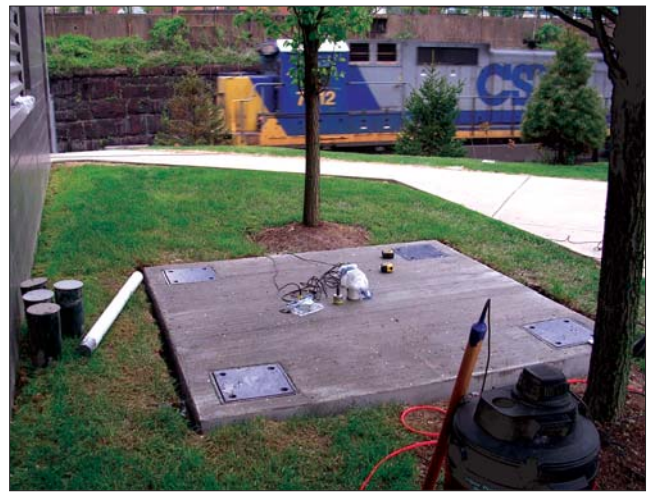
Figure 6. Subscale vibration isolation test floor.

The test floor was an 8 × 8 × 1 ft reinforced concrete slab supported by four helical coil springs from Mason Industries at each corner on 6 ft centers.⁹ Careful attention was paid to specify springs having similar stiffness values both vertically and horizontally. This created lateral stability for the floor and caused the natural frequencies for the other rigid body modes to be similar. The springs rested on a foundation consisting of a 6-in. concrete slab with 18-in. footers around the perimeter. A vertical PVC pipe was cast into the floor to allow instrumentation access to the foundation slab. A photograph of the subscale test floor is shown in Figure 6.

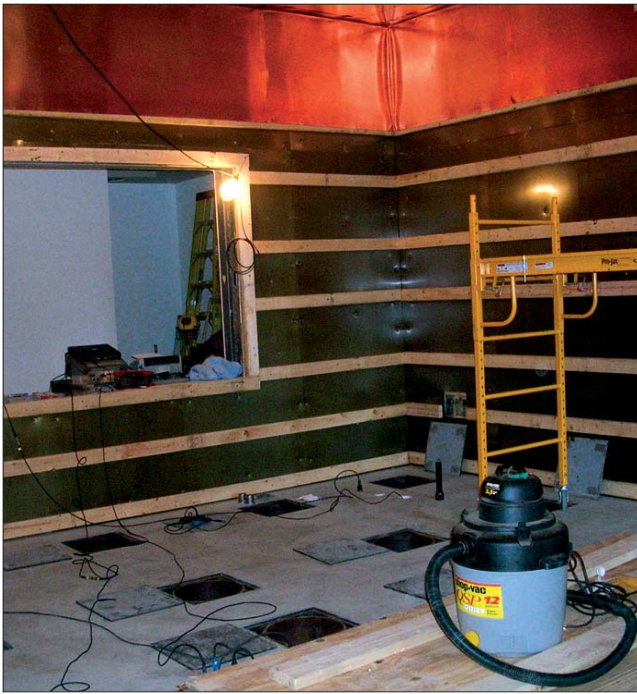
Figure 12. Vibration isolated MRI room during construction.

Approximately midway through the construction timeline, the vibration isolation performance was evaluated. Figure 12 depicts the construction state when tested. Note that a large plywood construction access door was located on an outer wall

that provided direct line of sight to the trains when open. The steel/copper cladding on the walls and the top access plates for the coil springs is apparent. At this point, the room was completely floating, with the only physical contact to the surrounding facilities being through the 25 coil springs. Five PVC pipes were cast in the floor slab to allow accelerometers to be placed on the foundation slab.

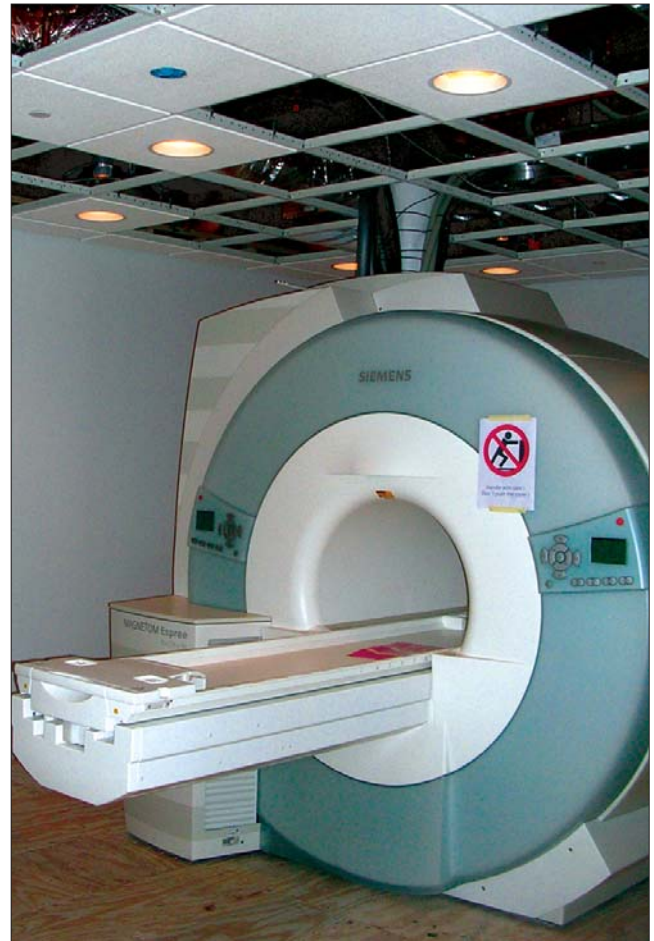
Figure 14. Vibration isolated MRI room nearing construction completion.

After the MRI was installed and the examination room was nearing completion, site vibration tests were again performed. The almost finished construction can be seen in Figure 14. At this point, the construction access door was removed and replaced with a solid wall. All mechanical utility connections (HVAC, electrical, magnet cooling supply) between the station-
